## DPR Avoids Substantial Construction Delays by Finding Out-of-Tolerance Interior Steel Beams with Verity

### Verity Identified As-Built Deviations in More Than 50% of Horizontal and Vertical I-Beams

### The Project: High-End Retail Site in Downtown Nashville

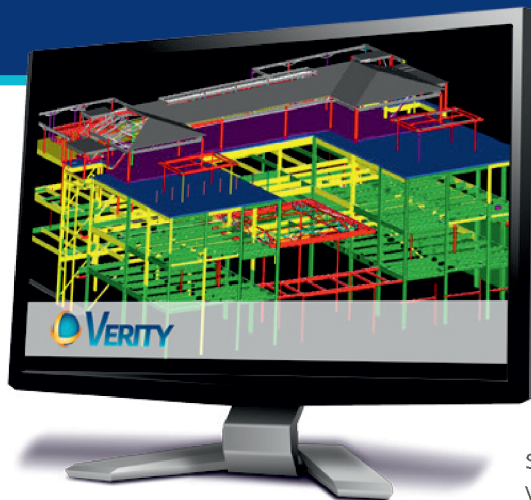
More than 50 percent of the installed steel was out of tolerance, with numerous beams deviating substantially from the design intent.

of the entire structure, which confirmed a deviation cascade from the ground up. There were 19 and 39 members out of tolerance on the first and second floors, respectively. Nearly all were out of tolerance on the third floor. The Verity report allowed DPR to evaluate each steel beam individually to determine if the deviation required a field inspection. One critical beam was designed to angle down but was installed flat, a scenario that would likely have been missed by spot checks.

Forty-five elements were flagged because they were either missing or were so far out of tolerance they could potentially impact construction of the exterior building skin—one exterior beam was out of tolerance by more than two inches, seriously jeopardizing the fit of the yet to be installed cladding.

DPR sent crews to the site with 2D schematics to review the 45 flagged deviations. This information was also

supplied to the designers to determine how to best remediate the problems prior to beginning the installation of exterior building skin. In addition, DPR ran the as-built model back through Navisworks to perform clash detection so field crews would be ready for future problems before they arise. Potentially major delays were avoided using Verity.
