## DPR Avoids Substantial Construction Delays by Finding Out-of-Tolerance Interior Steel Beams with Verity

### Verity Identified As-Built Deviations in More Than 50% of Horizontal and Vertical I-Beams

### The Project: High-End Retail Site in Downtown Nashville

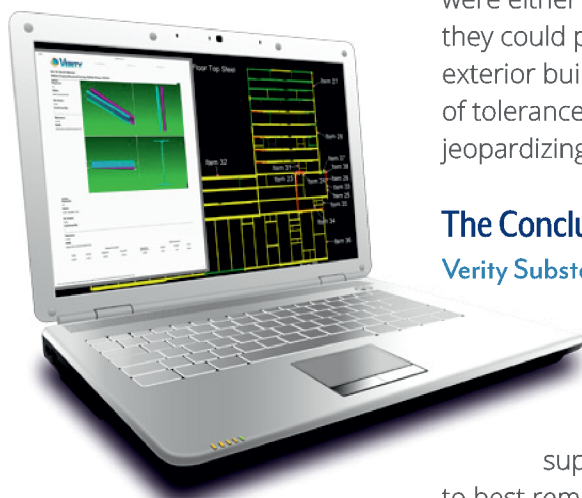
Verity generated a detailed HTML report as well as a color-coded model

of the entire structure, which confirmed a deviation cascade from the ground up. There were 19 and 39 members out of tolerance on the first and second floors, respectively. Nearly all were out of tolerance on the third floor. The Verity report allowed DPR to evaluate each steel beam individually to determine if the deviation required a field inspection. One critical beam was designed to angle down but was installed flat, a scenario that would likely have been missed by spot checks.

Forty-five elements were flagged because they were either missing or were so far out of tolerance they could potentially impact construction of the exterior building skin—one exterior beam was out of tolerance by more than two inches, seriously jeopardizing the fit of the yet to be installed cladding.

DPR sent crews to the site with 2D schematics to review the 45 flagged deviations. This information was also

supplied to the designers to determine how to best remediate the problems prior to beginning the installation of exterior building skin. In addition, DPR ran the as-built model back through Navisworks to perform clash detection so field crews would be ready for future problems before they arise. Potentially major delays were avoided using Verity.
